YOUR INSPECTION REPORT

Leisure
Pool and Spa

1000 Woodland Drive / Ogden,
Utah 84403

07/06/2019

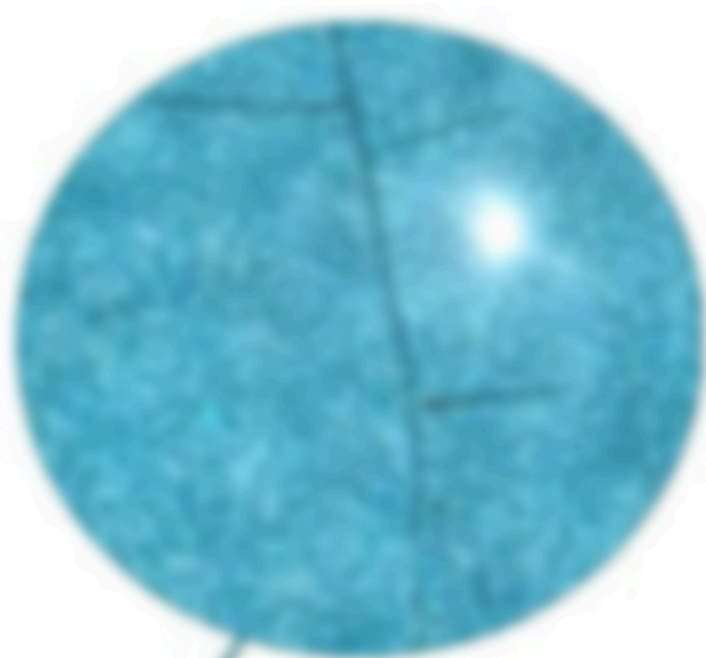
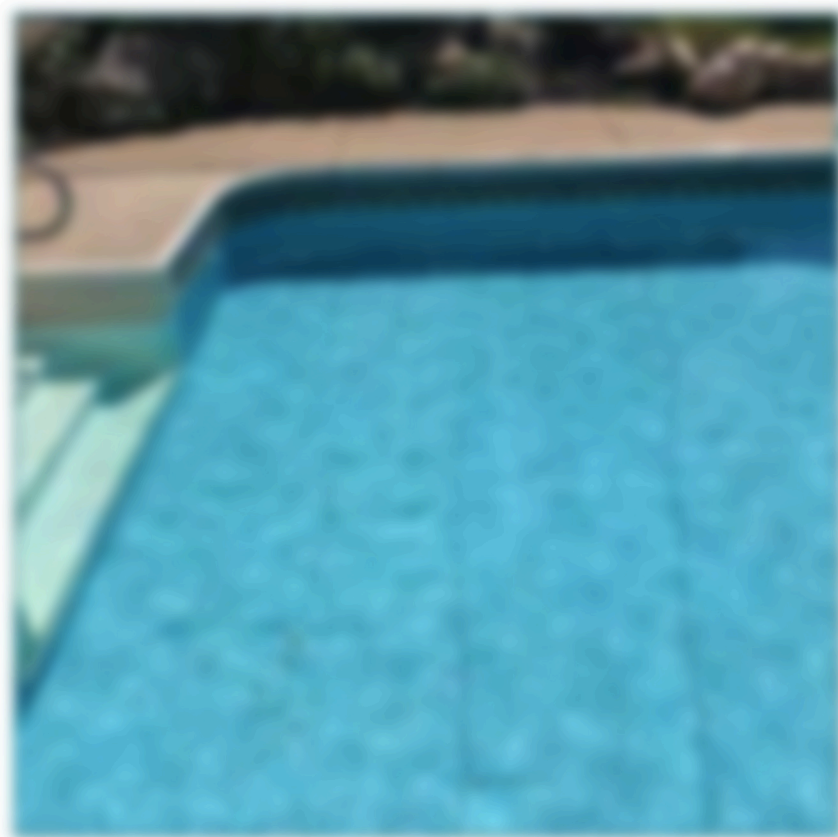
Pool has a vinyl liner that has severely rotted at low flow areas in the deep end typically caused by chemical sitting directly on the vinyl surface. It has long erosion up the glideside and in the shallow end so vinyl floor erosion are perforated and worse. We took pictures and performed diving inspection. 01/17/18. Must repair perforated water line. Lintex Pool and Spa is responsible replacing the liner. Estimated cost to replace \$4,500-\$5,000.

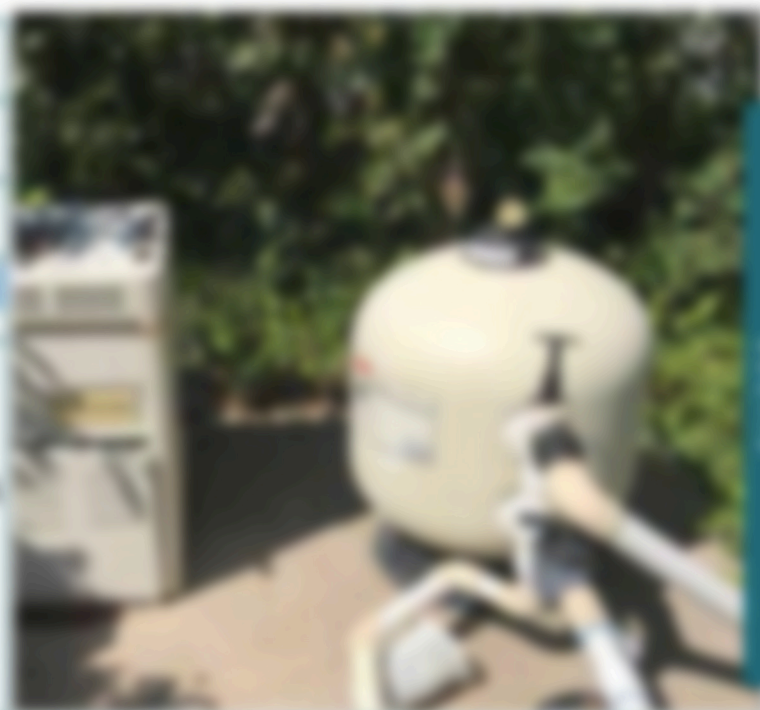
Model	Protek
Make	Haydon 60
Condition	Good N/A
Notes	Filter does not appear to be working and appears to be filtering properly the last date of next change is unknown. LFI recommended replacing the sand every 5-7 years
